Attachment 2 Conner Creek Fish Passage Improvement Project

Plan Views and Other Diagrams Crossing #1 (Conner Creek Rd) & Crossing #2 (Red Hill Rd)

Conner Creek Fish Passage Improvement Project Five Counties Salmonid Conservation Program Conner Creek Road & Red Hill Road - Trinity County

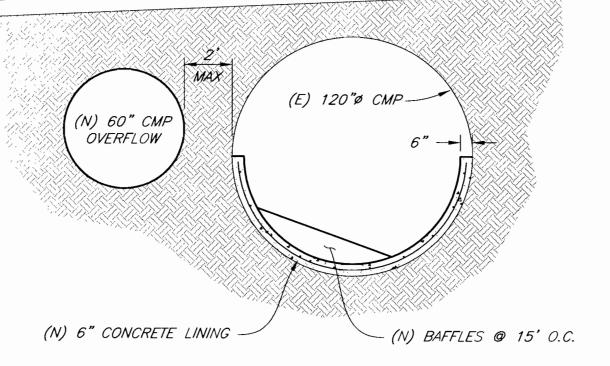
Figure 9

Conner Creek Culvert #2 Trinity County, California 60 Glen Road, Weaverville, California Alternative 2b Culvert Section D SHN 506057

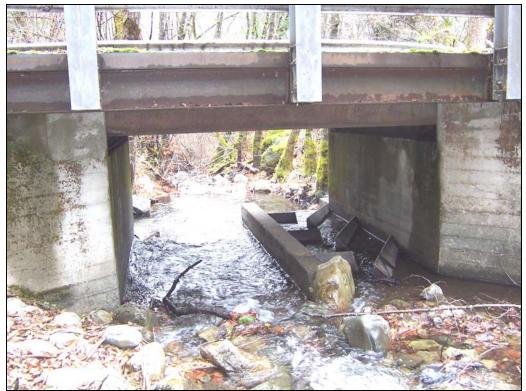
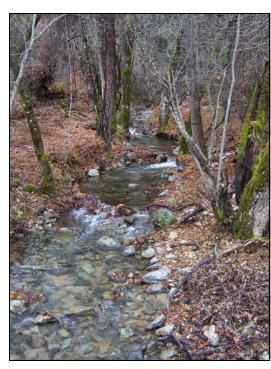
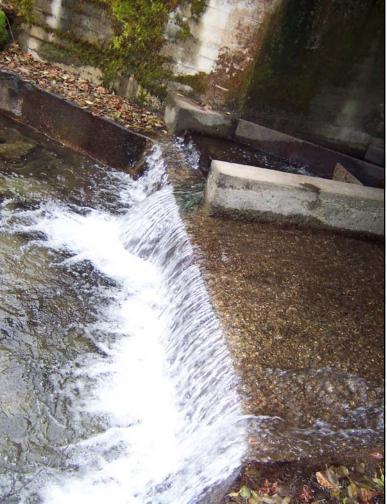
Top & Bottom Left & Bottom Right:
Concrete box culvert of Crossing
#1 showing sheet flow, outlet jump,
baffles and debris clogging

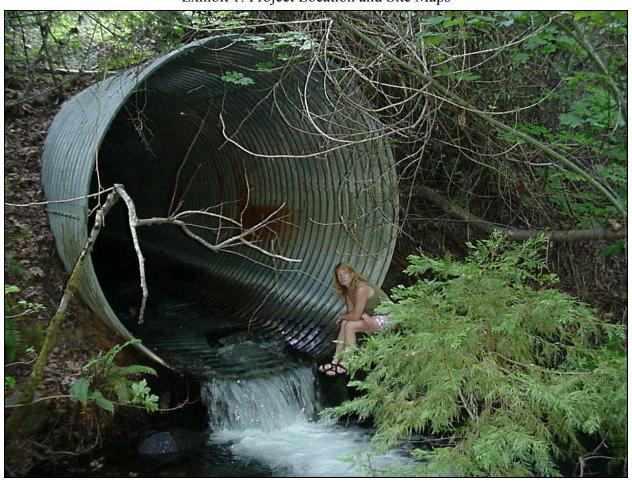
Outlet of culvert at Crossing #2 showing outlet jump
